UNITED STATES ENVIRONMENTAL PROTECTION AGENCY, REGION 2  
CARIBBEAN ENVIRONMENTAL PROTECTION DIVISION

DATE: DEC 21 2016

SUBJECT: Follow-Up to Citizen Complaint  
Tallaboa Encarnación Community  
Peñuelas, Puerto Rico

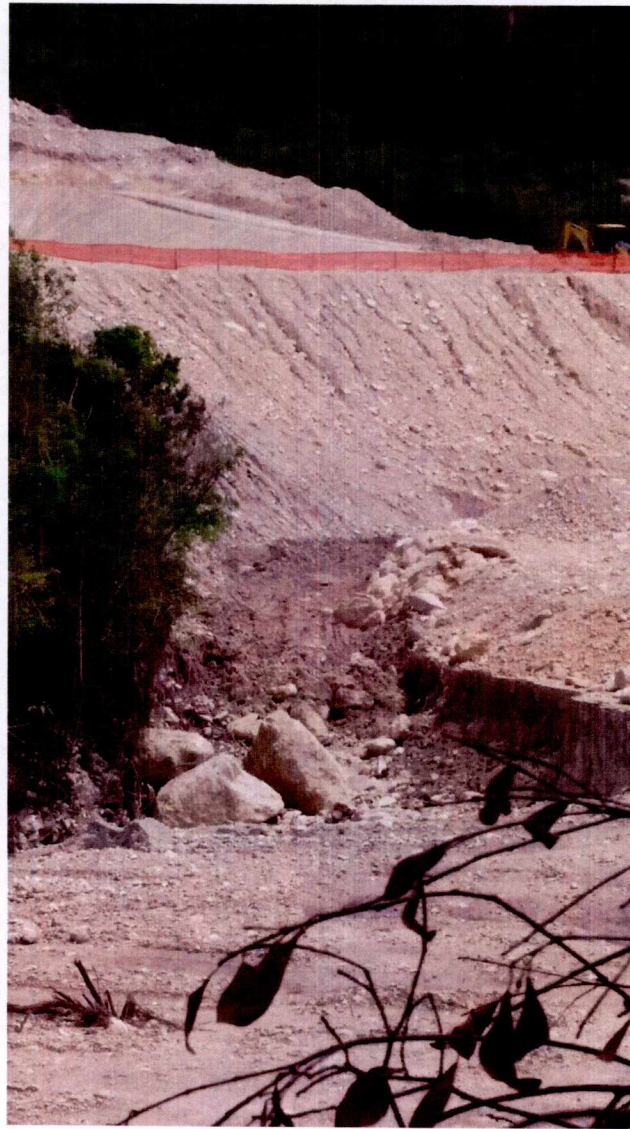
Cause de quebrada directamente afectado por construcción

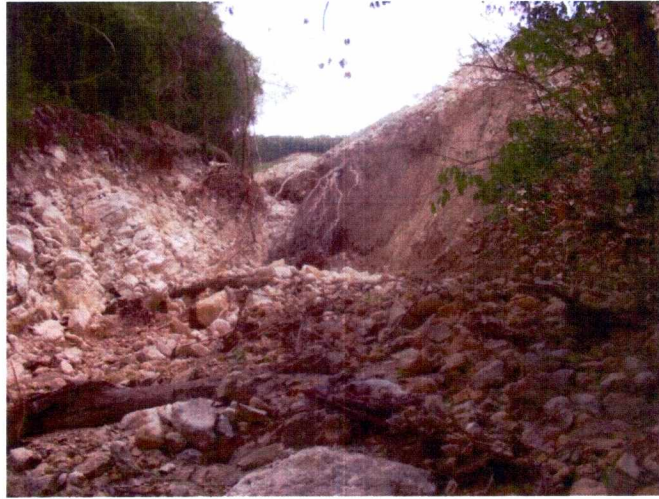
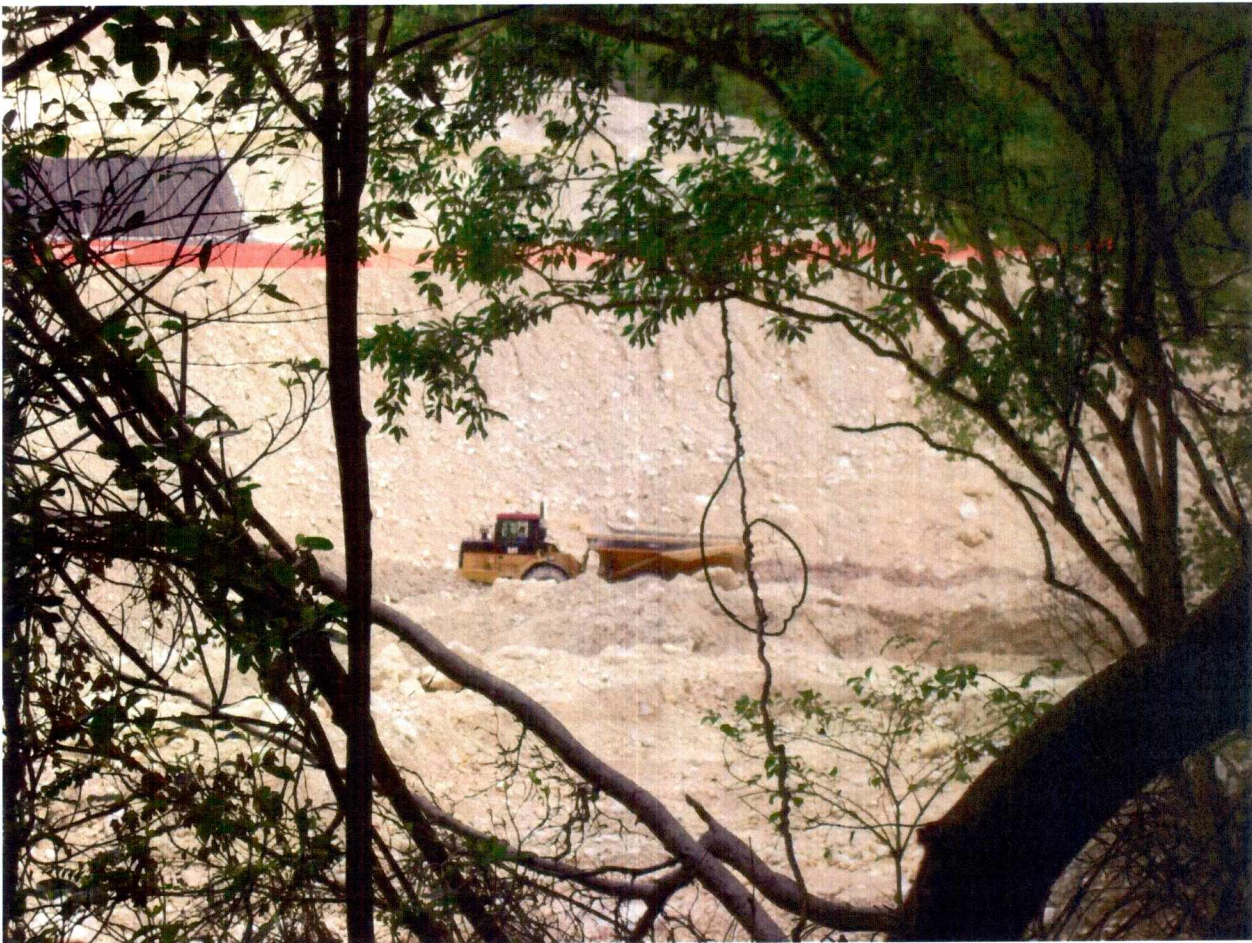
Paso de equipo pesado por el cauce de la quebrada

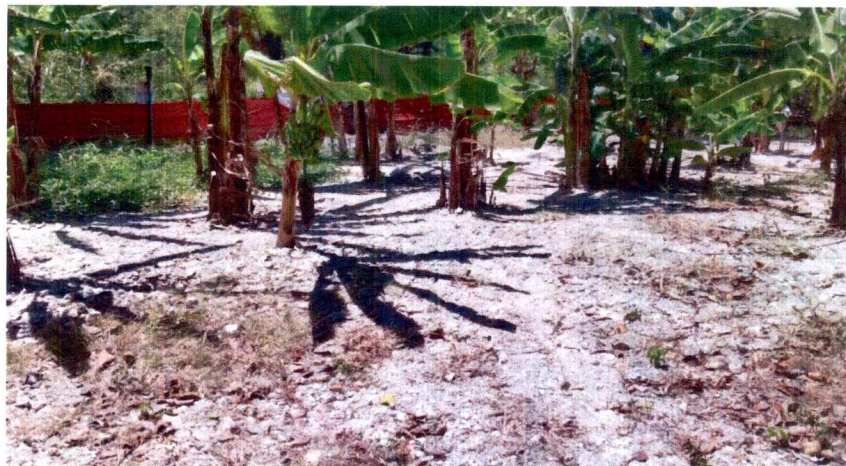
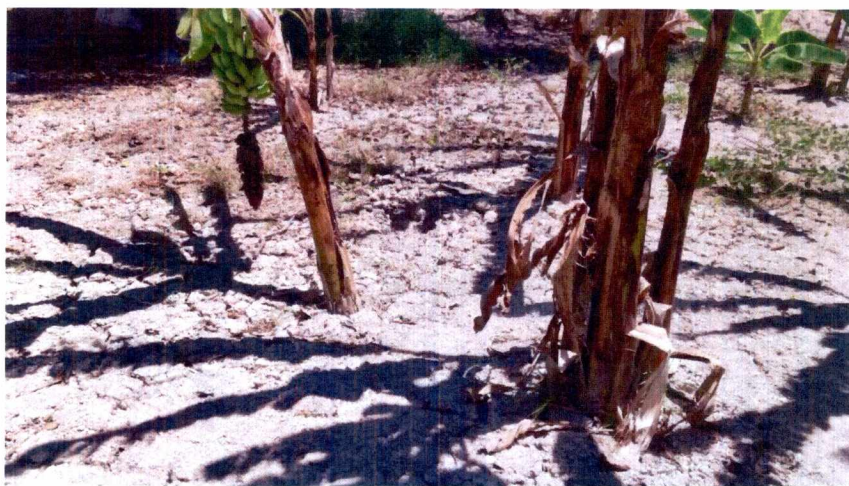
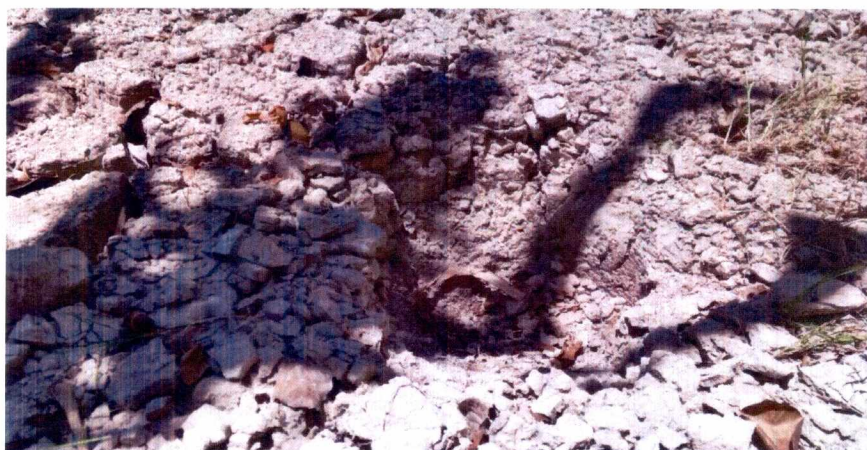
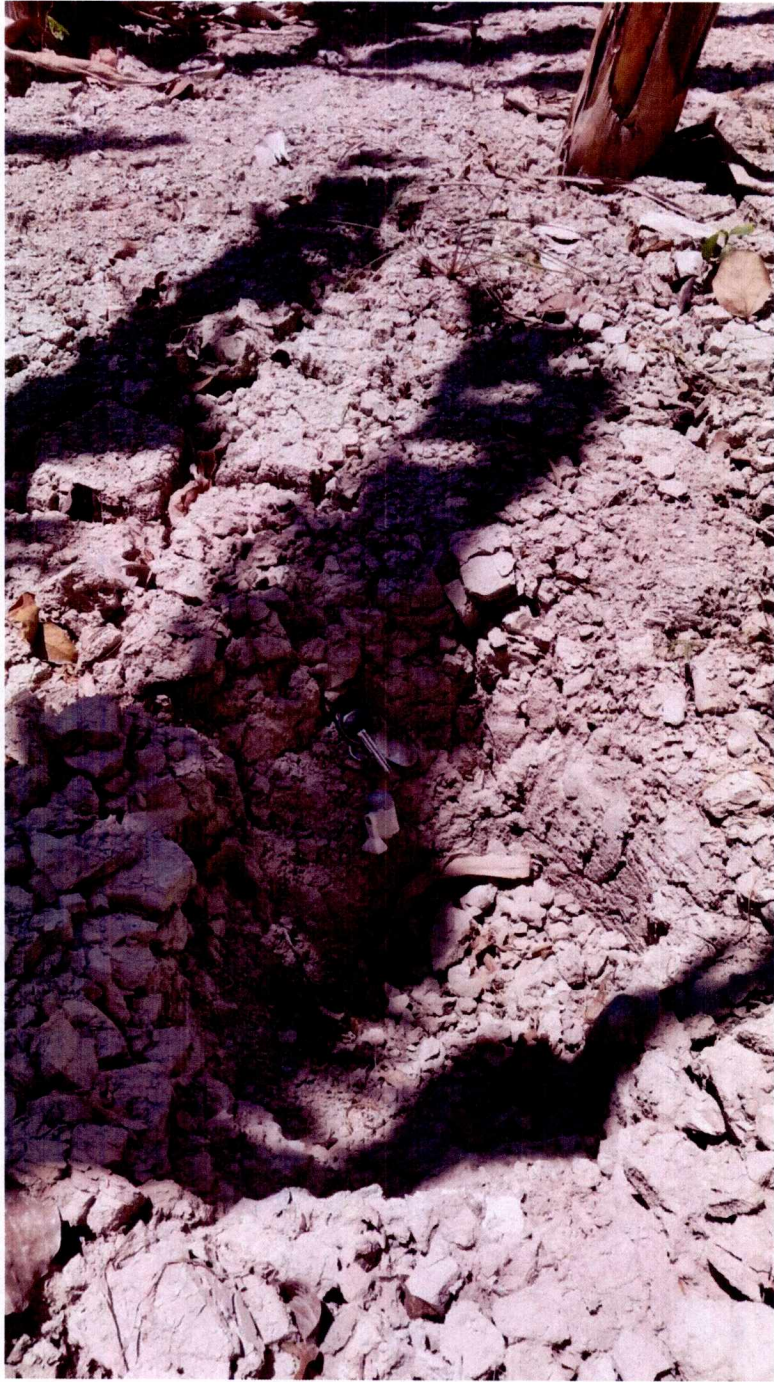
**Cenizas arrastradas por las escorrentías desde Ecosystems hasta la comunidad de Tallaboa en Peñuelas**

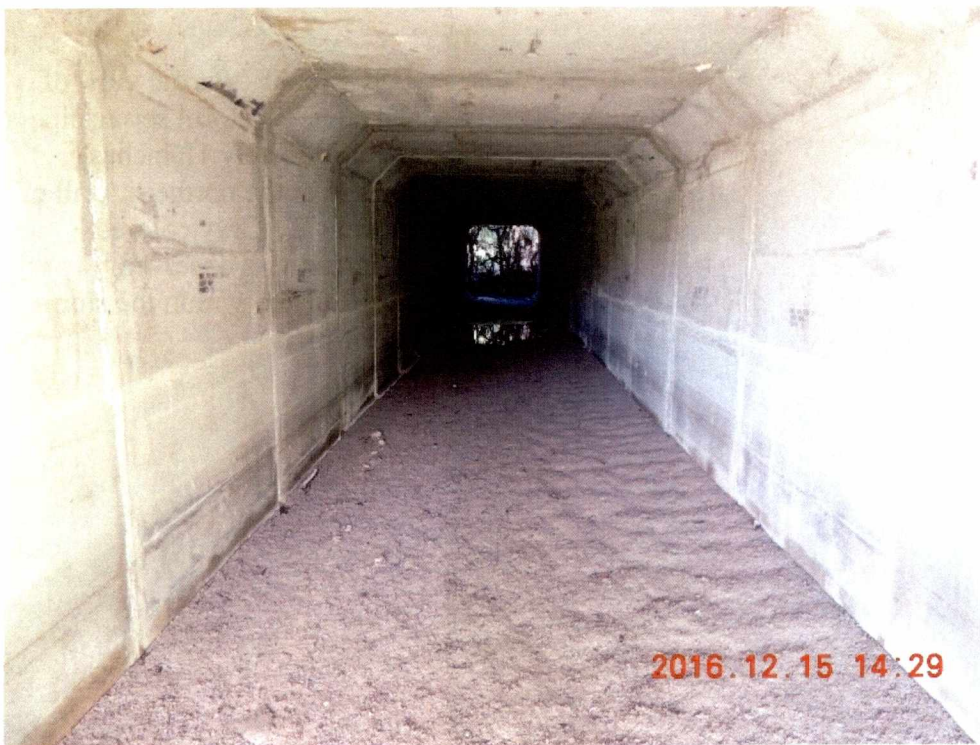
**DSCN0232** – Partial view of the Box Culvert (10X10 ft) north of Road PR-2 and adjacent to a private property access road. Light brown colored mud was observed accumulated within the box culvert.

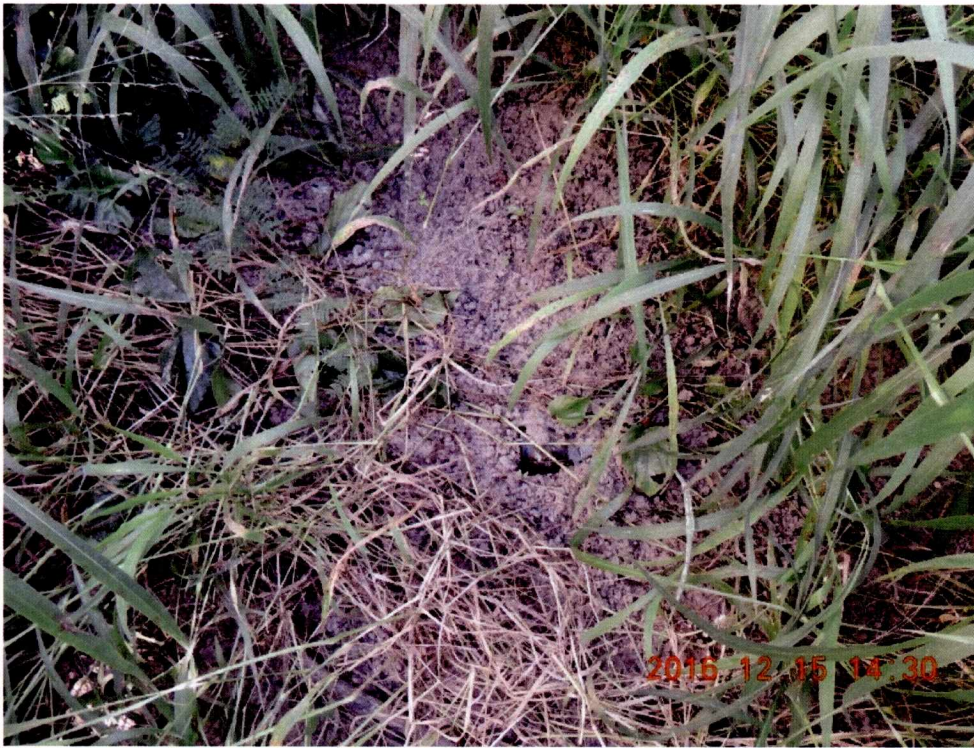
**DSCN0235** – Partial view of the intermittent creek open channel towards Road PR-2. Light gray dry sediment was observed accumulated in the bottom of the channel.

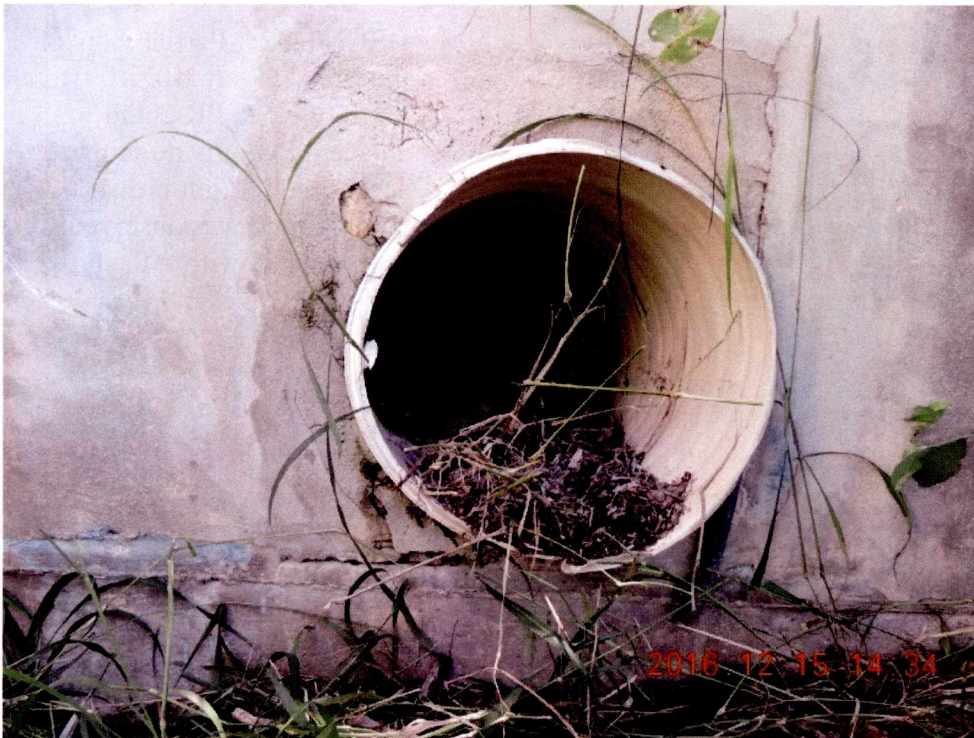
**DSCN0240** – Partial view of the apparent storm sewer pipe (approximately 12 inches) located at the northeast wall of the culvert. Gray colored sediment was observed accumulated within the storm sewer pipe.

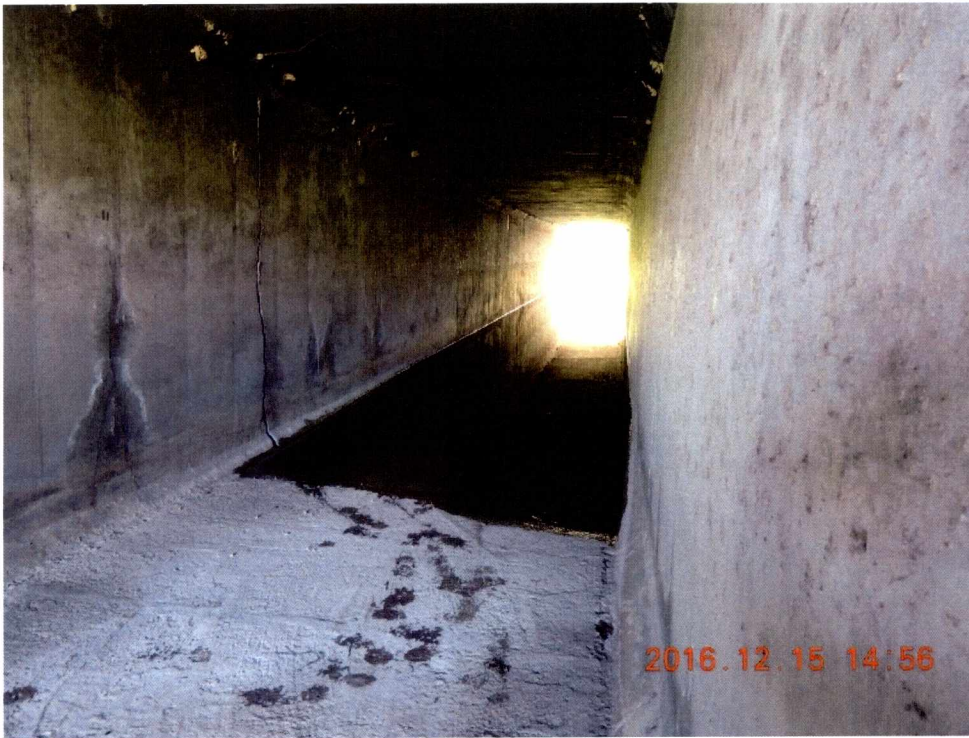
3	Box culvert (10X10 ft) north of PR-2 Loop and south of box culvert described in location #2.	18.000234	-66.721103	DSCN0247 to DSCN0254	<b>a.</b> Significant accumulation of stagnant water was observed accumulated within the box culvert. A gray colored water mark was observed in the bottom part of the culvert. <b>b.</b> The intermittent creek open channel north of the culvert was observed with significant vegetative cover. However, sediment accumulation was seen accumulated on its bottom. Gray colored sediment and mud was observed in the rip rap located just before the north entrance of the culvert.	Yes.

**DSCN0247** – Partial view of the box culvert located north of Road PR-2 and south of box culvert showed in photograph DSCN0232. Significant accumulation of stagnant water was found accumulated within the box culvert. A gray colored water mark was observed in the bottom part of the culvert.

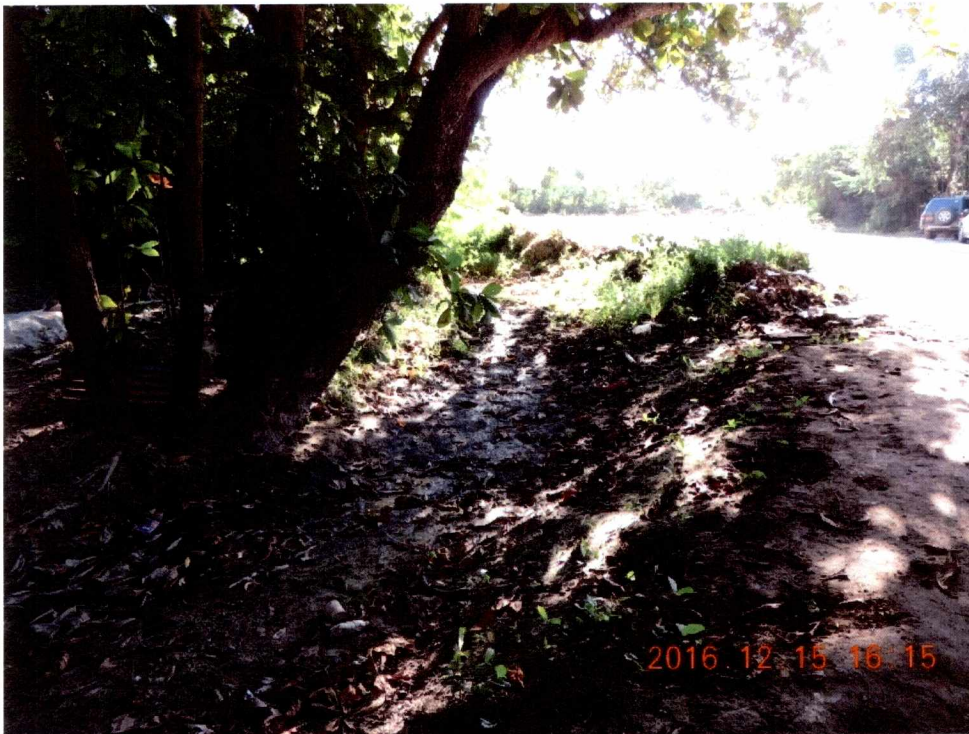
**DSCN0262** – Partial view of the intermittent creek open channel located near the back part of “El Velorio” bar at Road PR-127. Gray colored sediment was observed in the intermittent creek open channel.

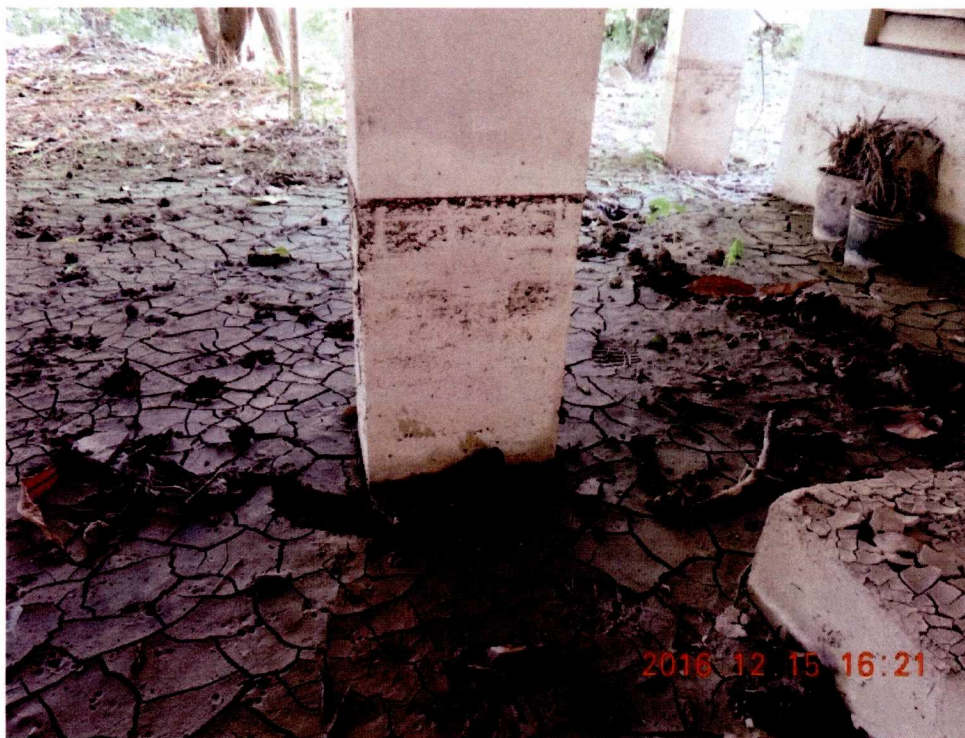
Location ID	Location/Reference Point	Latitude	Longitude	Photos	Summary of Findings	Potential Point for Soil Sampling?
7	Surroundings and back yard of two (2) residences located adjacently and east of "El Velorio" Bar at PR-127.	17.999114	-66.722547	DSCN0263 to DSCN0296	<p><b>a.</b> The surroundings and back yards of the residences were found with accumulation of gray-colored sediment with cement like characteristics. <b>b.</b> Approximately four (4) inches of sediment accumulated inside of the residence (Residence #1) closest to "El Velorio" Bar were observed. The sediment observed inside the residence was found muddy and gray colored. A piece of dry sediment located in front and outside part of Residence #1 was found with cement-like color. Based on Eng. Cotto statement, the owners of Residence #1 abandoned the property due to the flooding issues and the sediment accumulation. A water mark of approximately 36 inches was observed in the walls of Residence #1. <b>c.</b> Several plantains plants were observed in the back yard of the residence (Residence #2) adjacent to the residence described above. The back yard of the residences and plantains plants are similar to the ones showed in the photographs presented in the Complaint. Accumulation of gray colored sediment was also observed in the surroundings of Residence #2.</p>	Yes

**DSCN0267** – Partial view of the front part of Residence #1, in which dry gray colored sediment was observed.

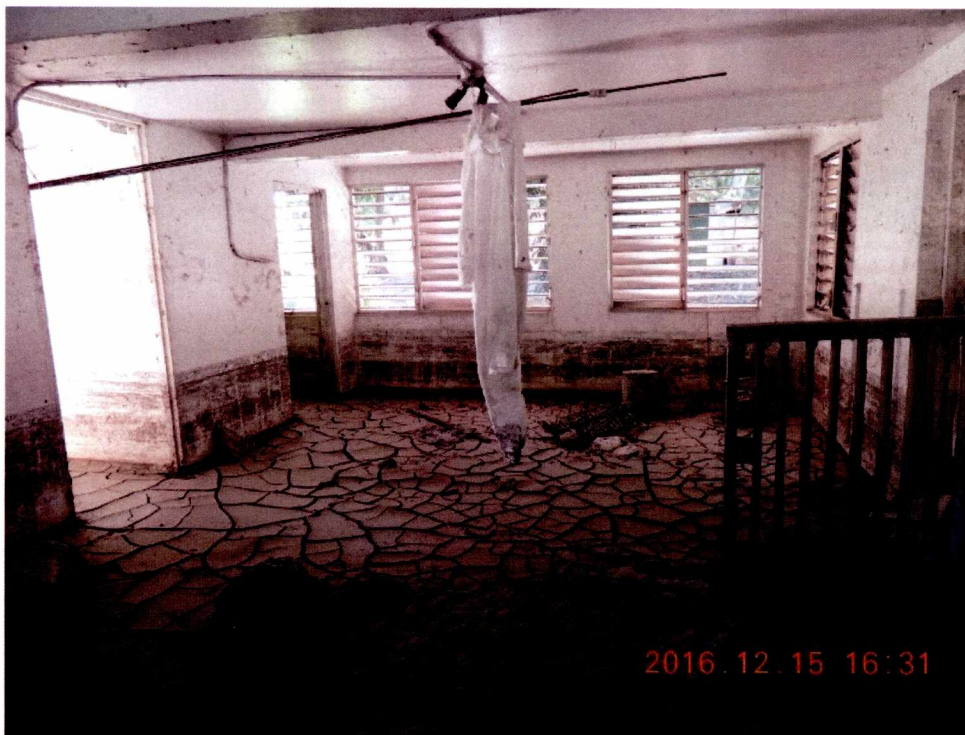
**DSCN0282** – Partial view of the inside part of Residence #1 adjacent to the intermittent creek and “El Velorio” Bar. Approximately four (4) inches of sediment accumulated inside of the residence.

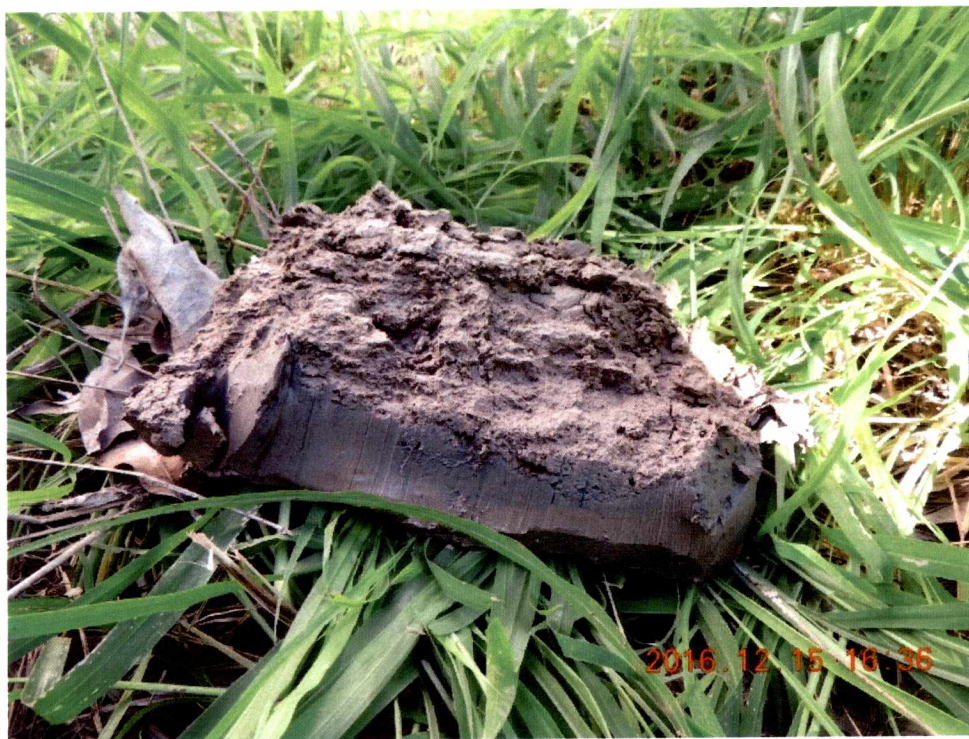
**DSCN0295** – Partial view of a piece of the sediment removed from the inside the Residence #1. The material was found muddy, wet, and had a gray color.

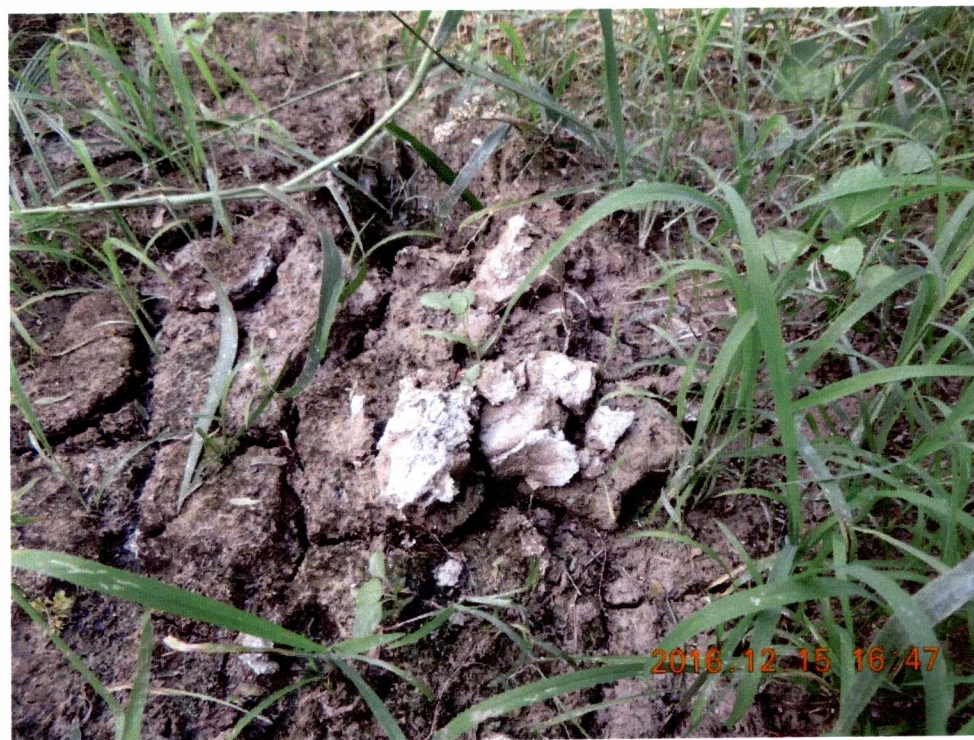
**DSCN0301** – Partial view of the intermittent Creek open channel downstream of "El Velorio" bar towards Tallaboa Bay. Gray colored sediment was observed in the bottom and slopes of the intermittent creek channel.
